INSTRUCTIONS TO FIT REAR CRANKCASE COVER & SEAL KIT (UE7488-BR)

ALL V8 ENGINE CARS FROM 1959 (SILVER CLOUD II & S2) THROUGH TO LATE SILVER SHADOW II & T2 MODELS (VIN 39529 APPROX)

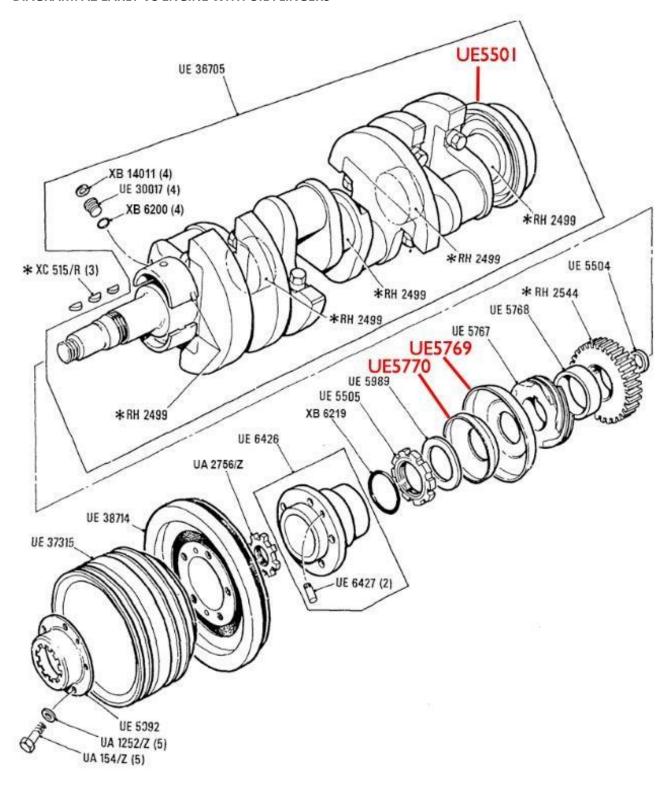
DIAGRAM: A2 EARLY V8 ENGINE WITH OIL FLINGERS

Originally the V8 engines were fitted with oil flingers to the front (UE5770 & UE5769) and rear (UE5501) of the crankshaft to prevent oil leakage – see diagram A2.

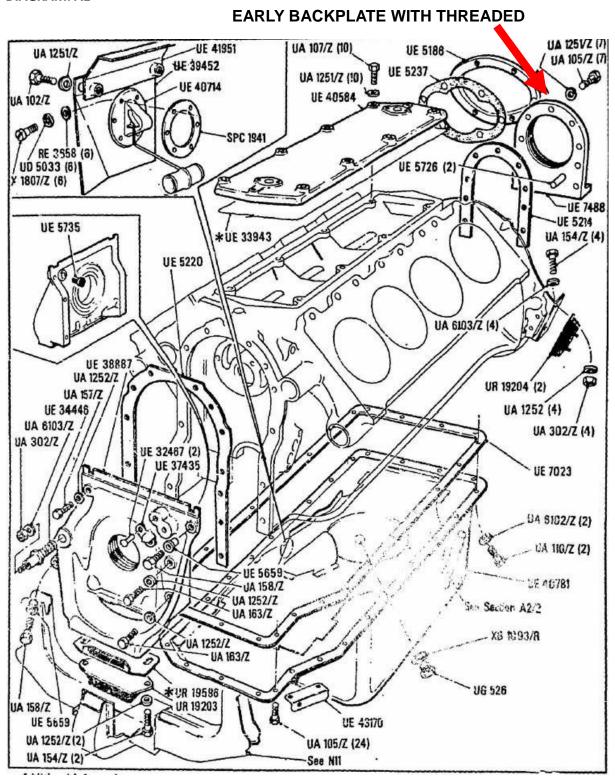
DIAGRAM: A1

The rear oil flinger is pressed onto the crankshaft and rotates inside a recess in the backplate on the rear of the crankcase which has an internal threaded scroll which is designed to throw the oil back into the engine - see diagram A1. These scrolls have a tendency to sludge up leading to oil leaks.

We have built a kit of parts to modify the early rear crankshaft set-up to accept the later style rear lipped oil seal.

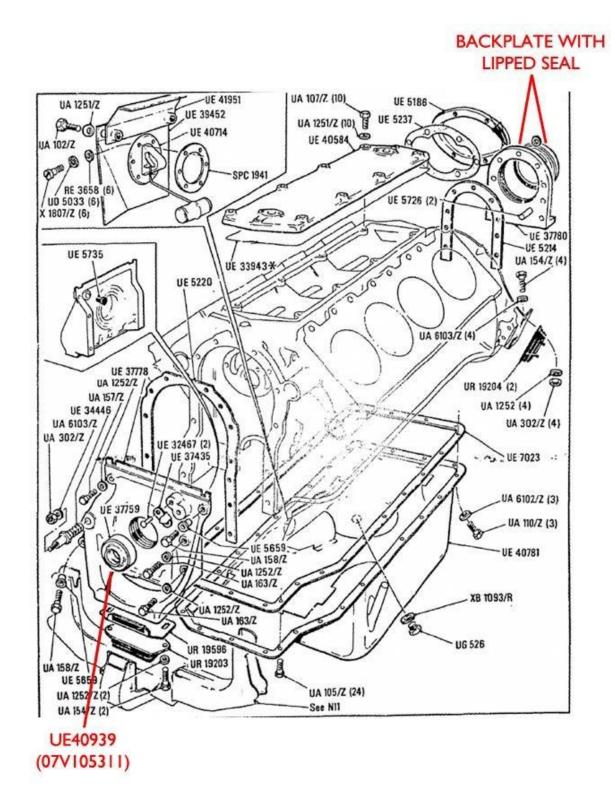
DIAGRAM: A3

Later cars from approximately 1979 were fitted with engines (referred to as B series) with lipped oil seals around the front (UE40939) and rear (UE44273) of the crankshaft - see diagram A3.

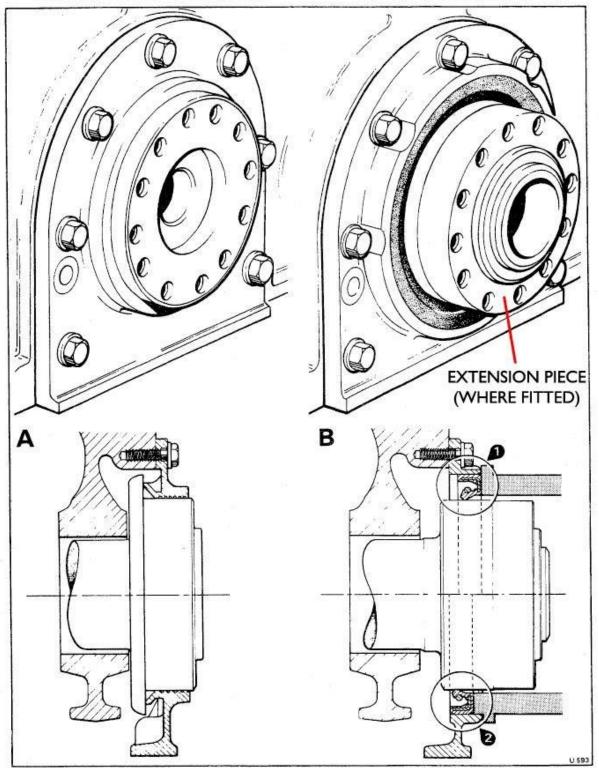
DIAGRAM: A5

You must ensure that the flinger is in the correct position and is flush with the end of the crankshaft and that the edge of the flinger is not too close to the extension piece (see diagram A5) on the end of the crankshaft (especially important if temporarily removing extension piece – we recommend marking on the extension piece where the crankshaft and extension touch).
